CONDITIONS SURVEY AND REPORT FOR THE RECONSTRUCTION OF FEDERAL GOVERNMENT COLLEGE, IKOM GATE

**SUBMITTED BY:
ALUMNI PROJECT COMMITTEE
DATE: FEB 2019**

CONDITIONS SURVEY AND ASSESSMENT

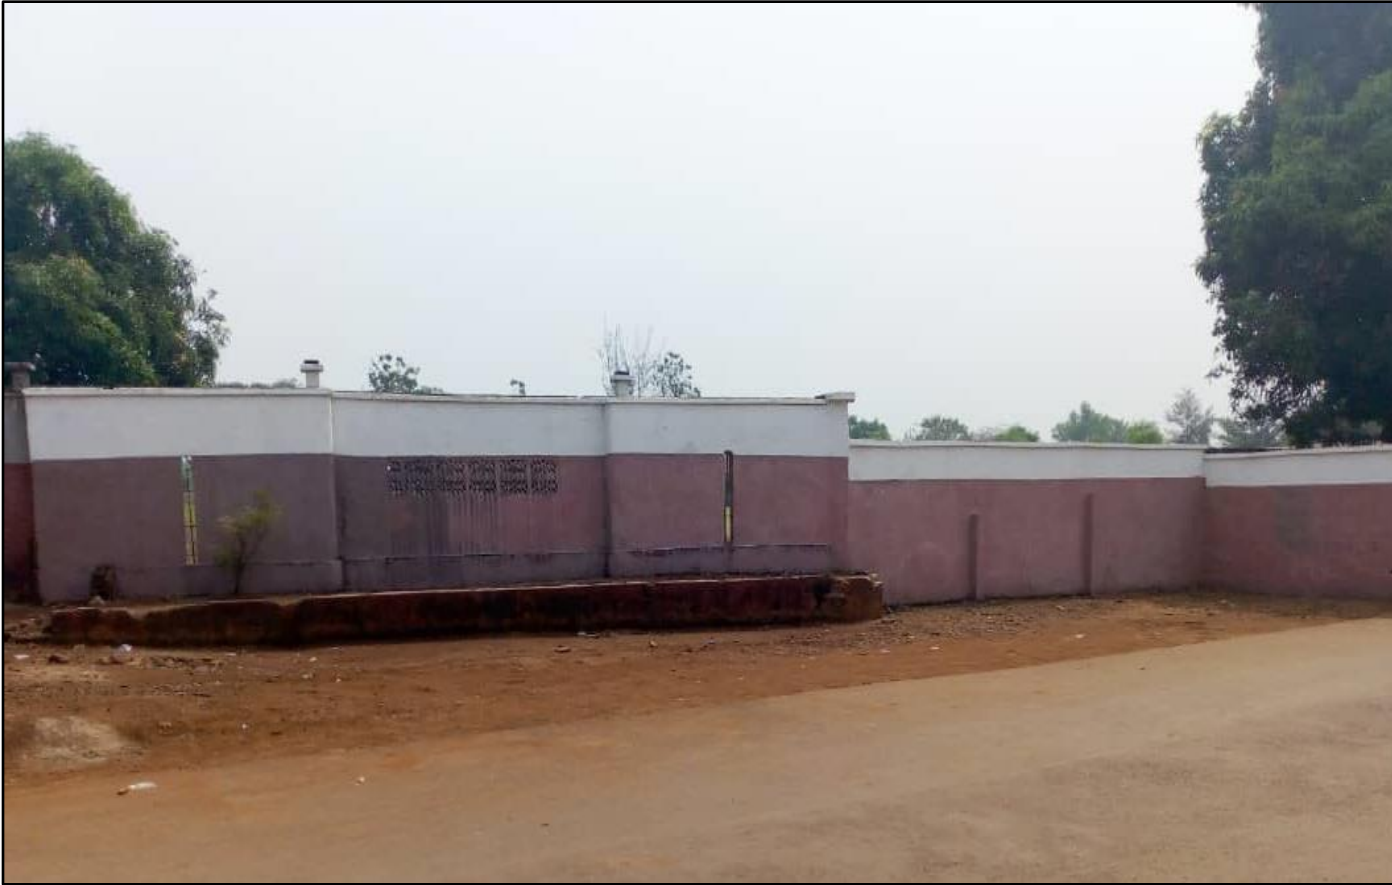
☐ **BEAUTIFICATION OF FENCE: AREA FOR PLANTING FLOWERS**

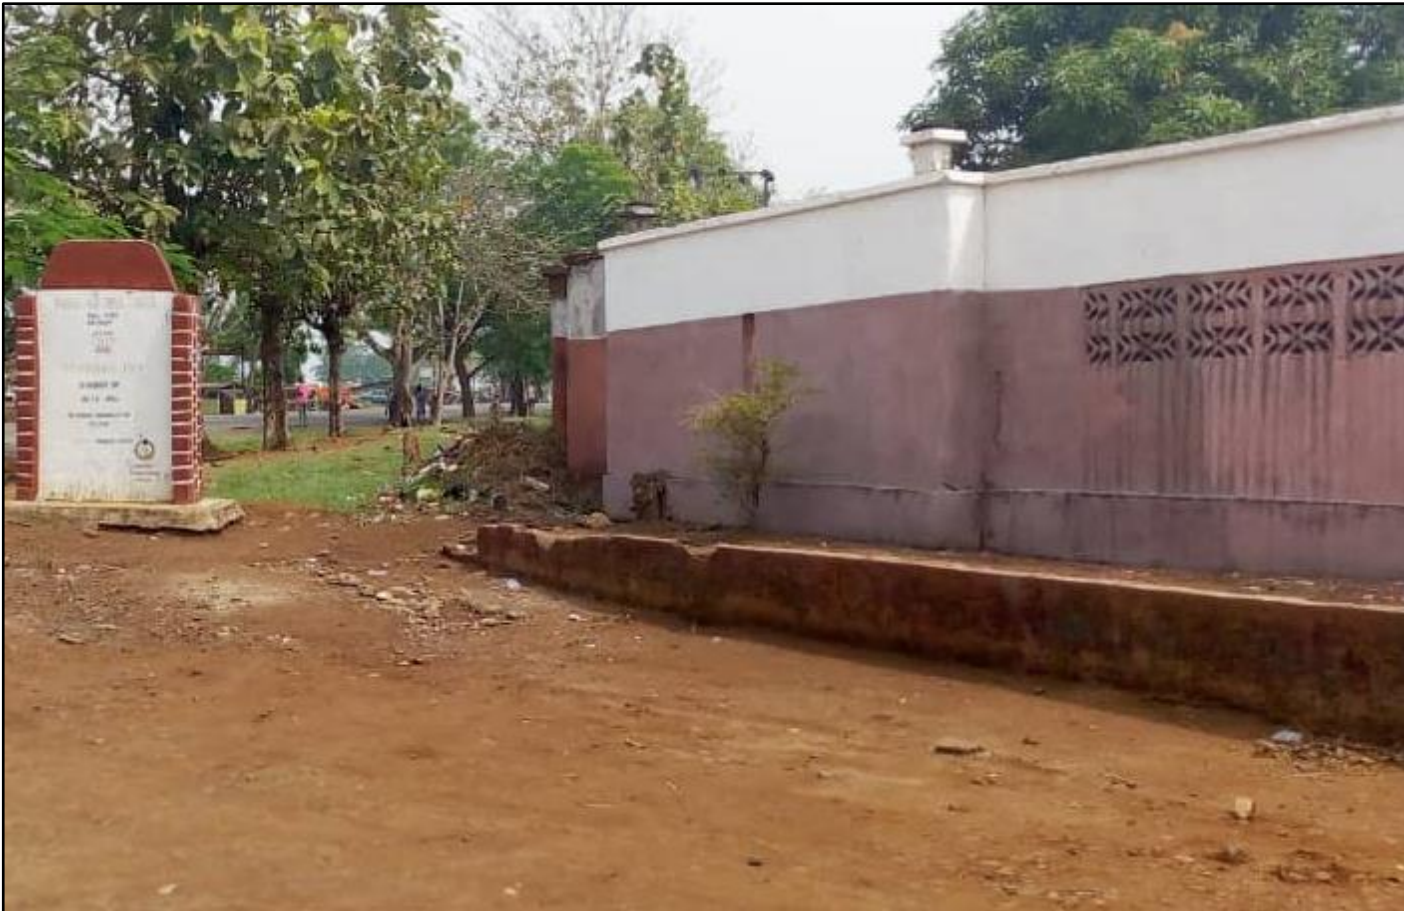
❑ **BEAUTIFICATION OF FENCE: AREA FOR PLANTING FLOWERS**

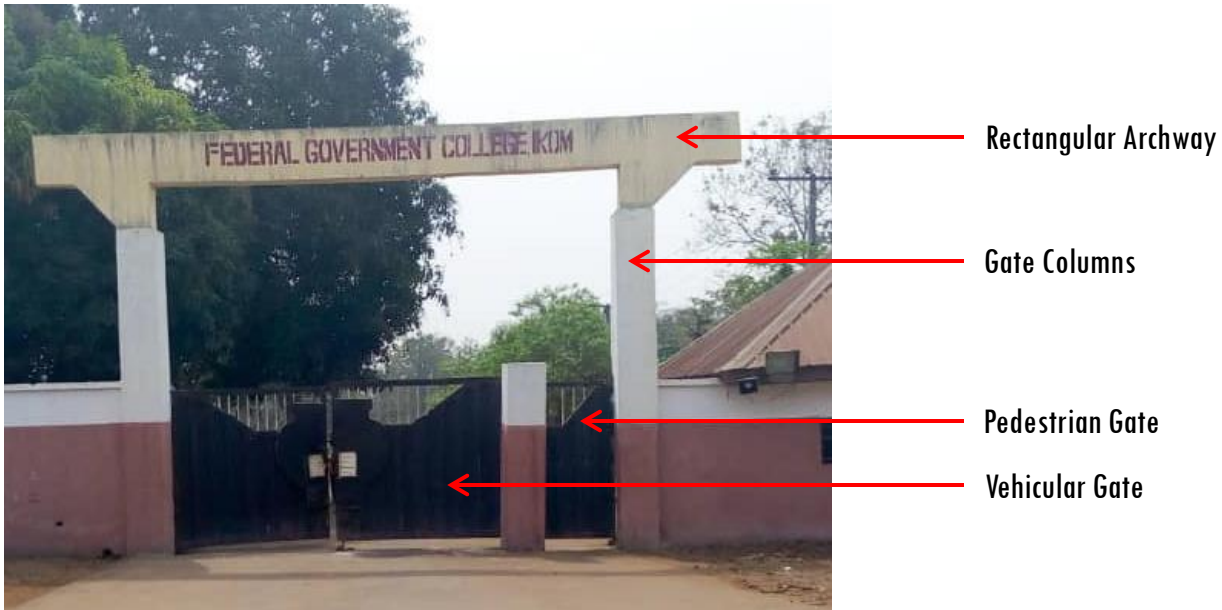
Fig 1. Picture Showing Gate Structure Condition

1. The Columns and the beam that forms the rectangular archway are in good structural condition but in poor aesthetic condition as shown in fig 1.
2. The Columns are irregular in shape , thus causing a visual distortion not concurrent with the image of the School.
3. The Steel Gate is structurally unstable and has a poor aesthetic quality.
4. The barricade is not in a good working condition.
5. The fence is in Structurally good condition and in of minimal remedial works.

1. It is recommended that the Gate Structure is upgraded to a more aesthetically pleasing one, so as to portray a more vibrant image of the School.
2. Paints/Wall finish to be used should be of high quality and have an anti-weathering component, such that the new gate structure can be used for up to 15 years without need for remedial works.
3. The Colors to be used on the gate should reflect the School Colors.

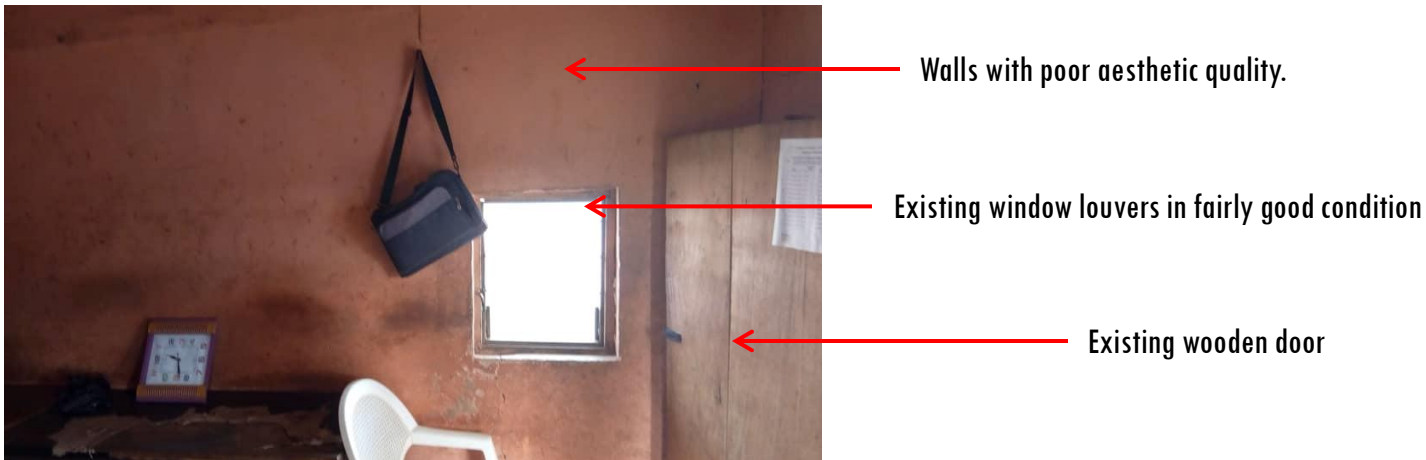
Fig 3. Picture showing the interior of the gate house.

1. The gate house is in fairly good condition, the roof structure was upgraded a while ago , and the external and aesthetic quality of the building is in need of remedy.
2. The windows are louver windows types and are in fairly good condition.
3. The internal walls are in good condition but have poor aesthetic quality.
4. The security hall space is constrained and cannot handle all the activities it would have been used for.
5. The door types are wooden panel doors and are not in good condition.

1. It is recommended that the Gate house is upgraded and all the items in fairly good condition be remedied.
2. It is of necessity (however optional) to increase the size of the security hall to accommodate a more defined space for:
Check in and Check-out Spaces for Students and Visitors.
3. The upgraded gate house should be done with the consideration of having the Pedestrian Access go through the gate house for better control and monitoring of pedestrian traffic.
