CONDITIONS SURVEY AND REPORT FOR THE RECONSTRUCTION OF FEDERAL GOVERNMENT COLLEGE, IKOM GATE

**SUBMITTED BY:
ALUMNI PROJECT COMMITTEE
DATE: FEB 2019**

CONDITIONS SURVEY AND ASSESSMENT

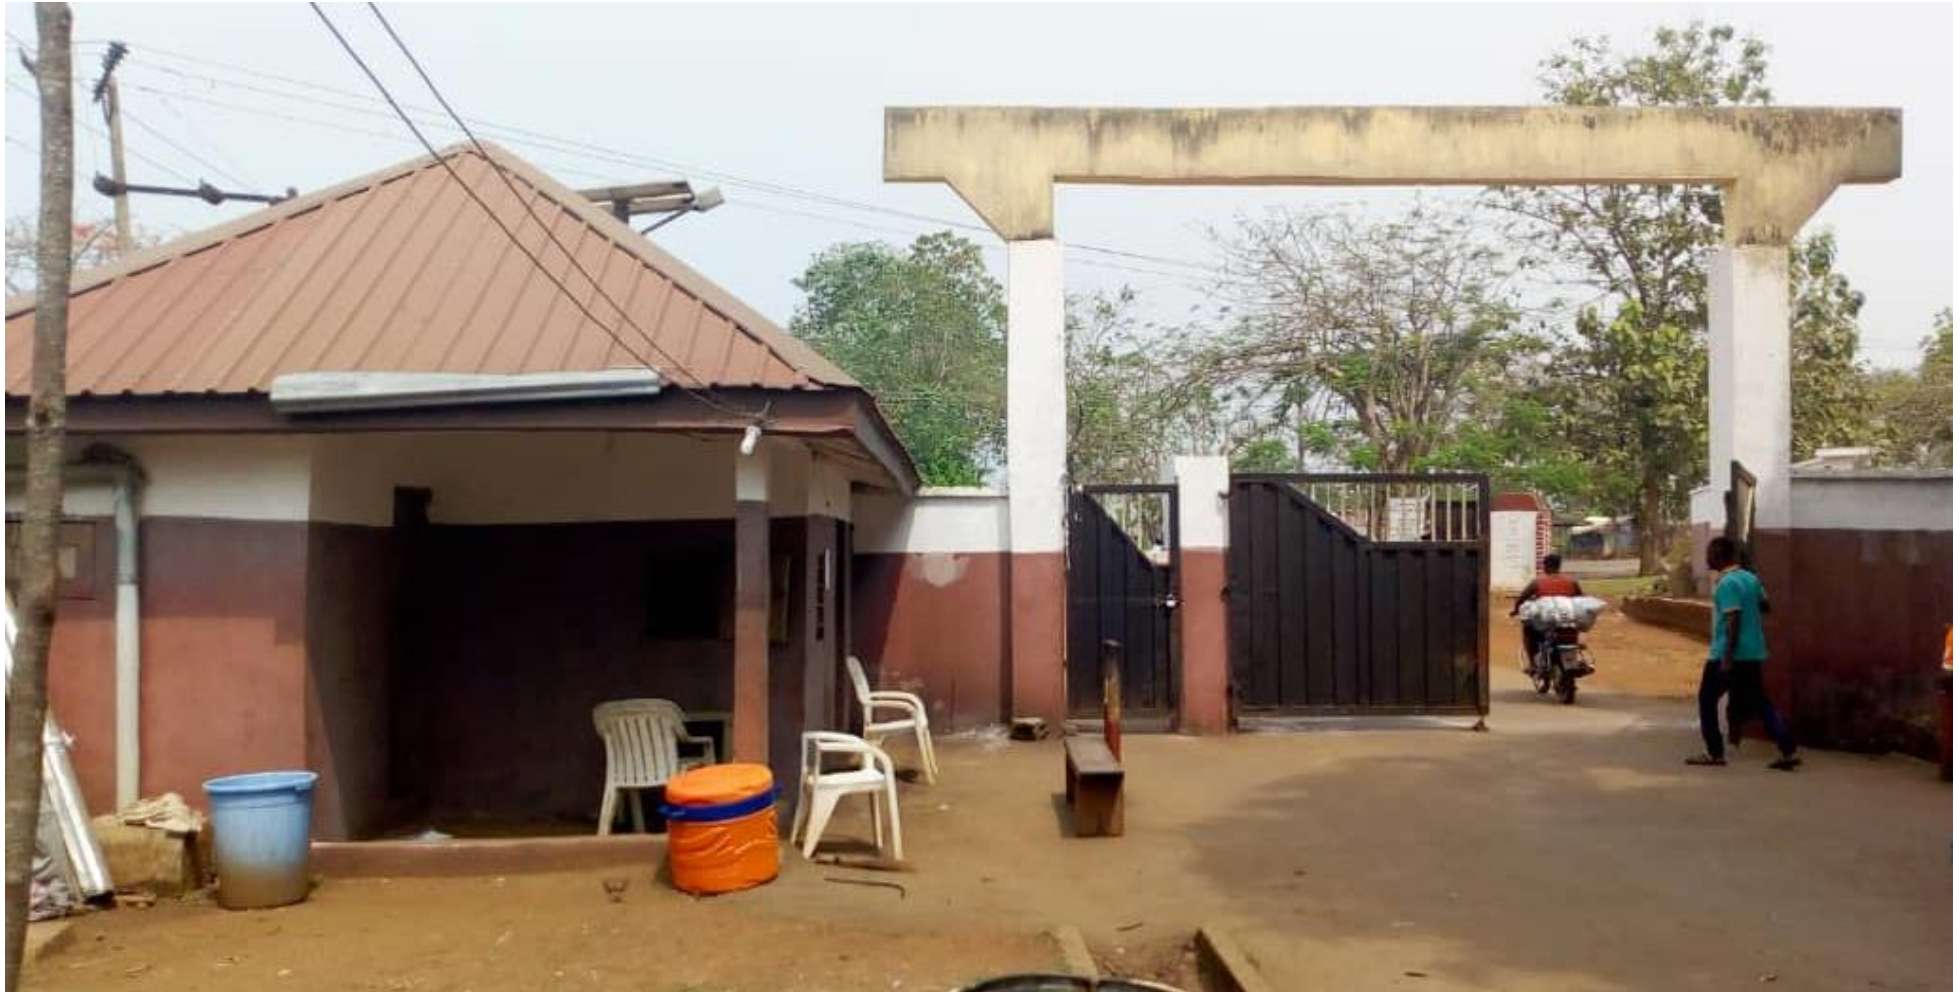
☐ **VIEW FROM WITHIN THE SCHOOL COMPOUND**

EXISTING GATE HOUSE

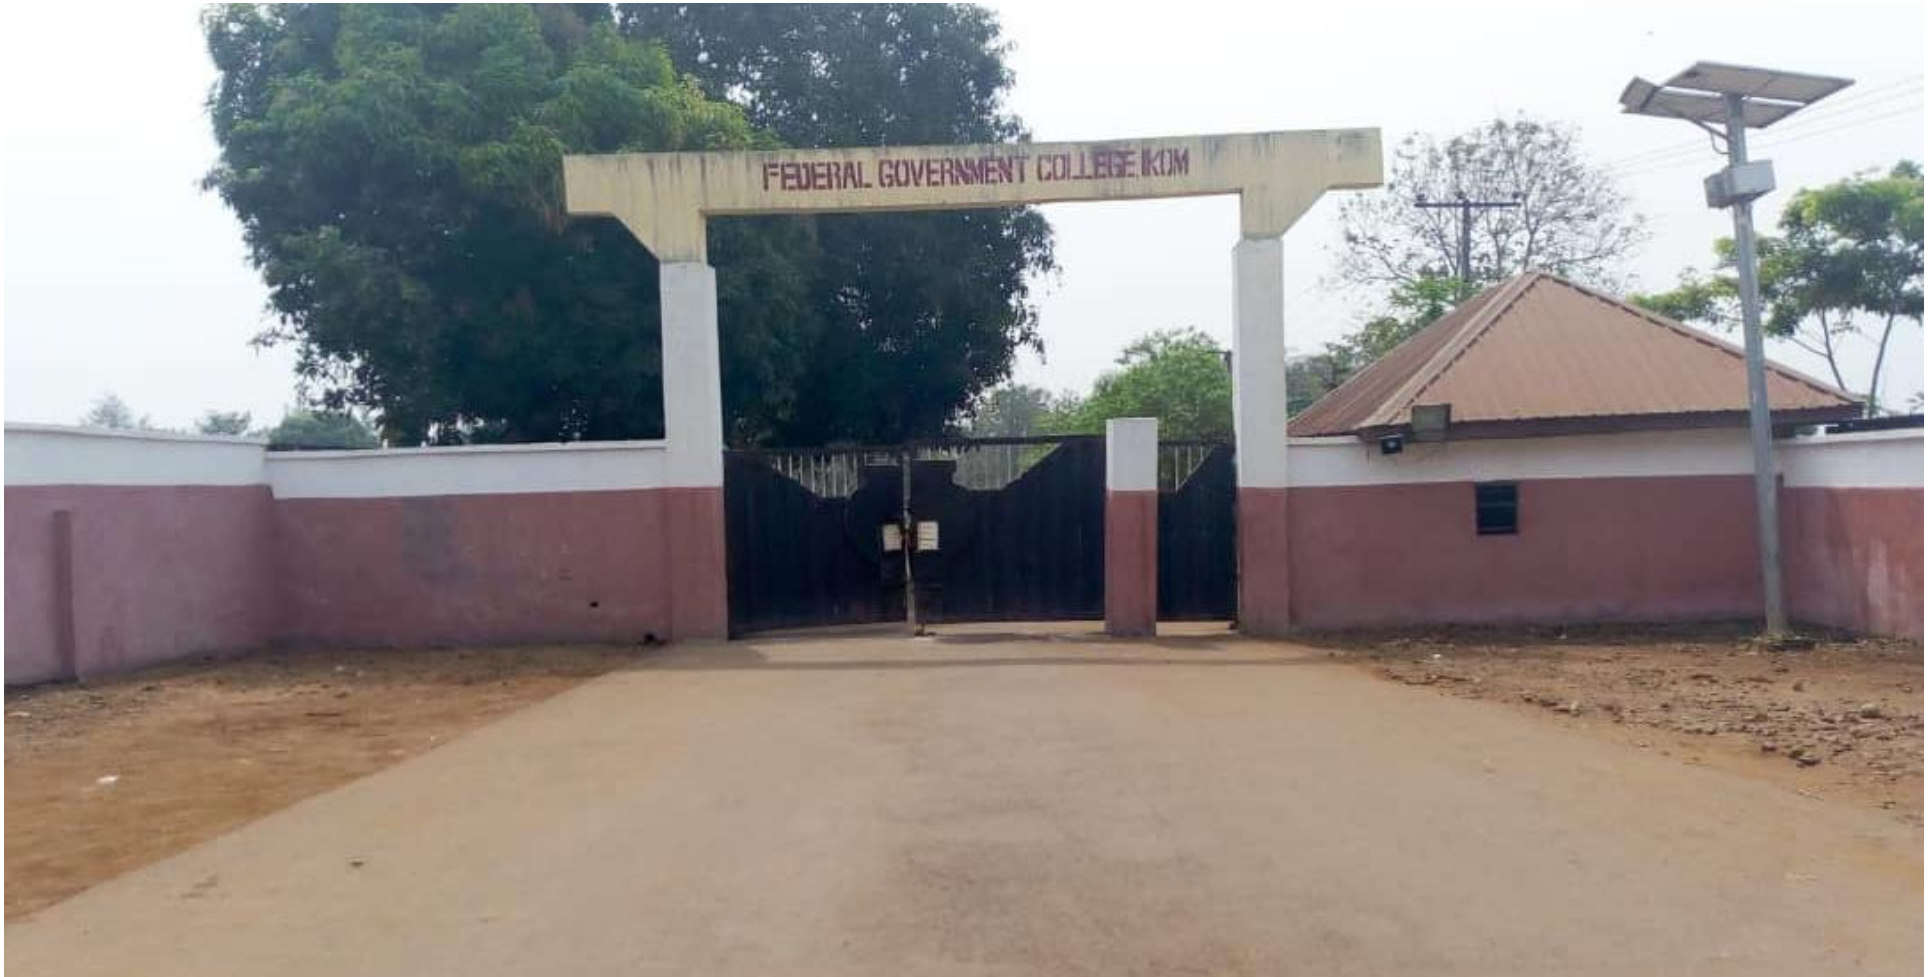
❑ **VIEW FROM IKOM-CALABAR ROAD**

EXISTING GATE HOUSE

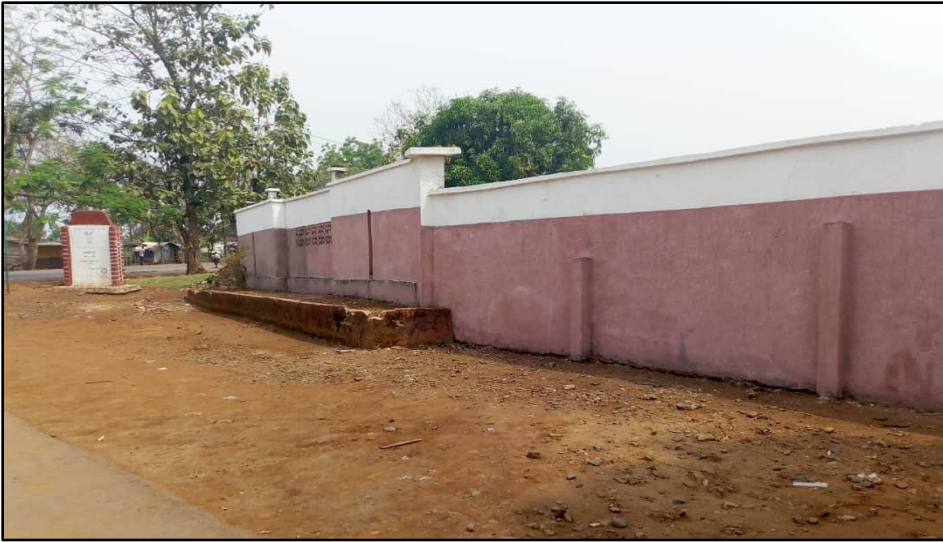
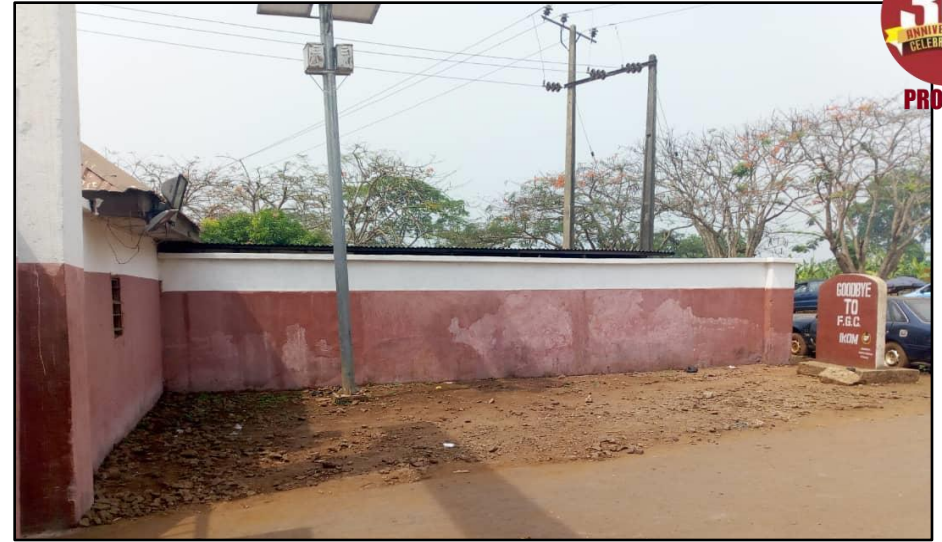
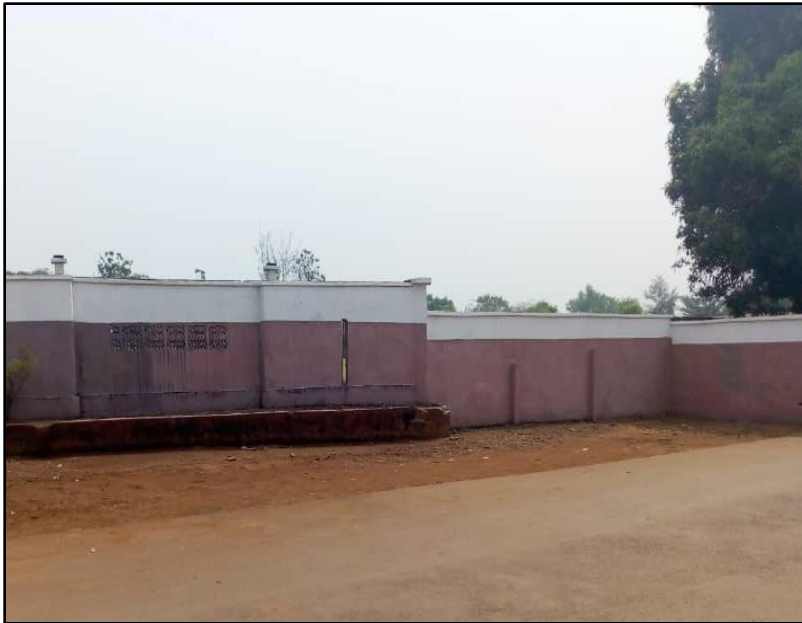
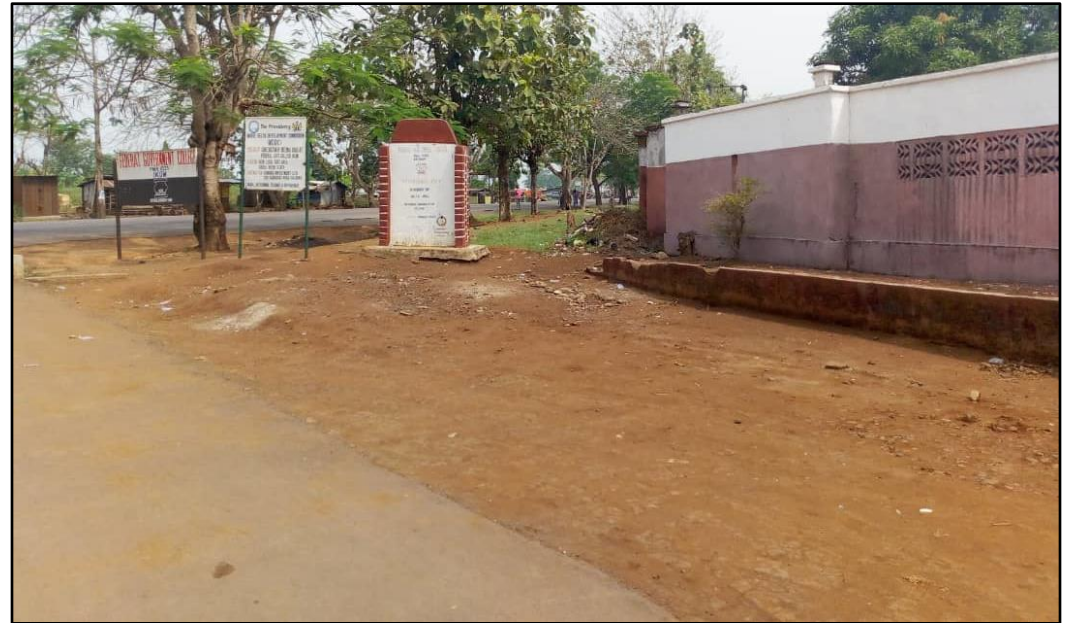
❑ **EXISTING FENCE : VIEWS FROM IKOM-CALABAR ROAD**

1. The Columns and the beam that forms the rectangular archway are in good structural condition but in poor aesthetic condition as shown in fig 1.
2. The Columns are irregular in shape , thus causing a visual distortion not concurrent with the image of the School.
3. The Steel Gate is structurally unstable and has a poor aesthetic quality.
4. The barricade is not in a good working condition.
5. The fence is in Structurally good condition and in of minimal remedial works.

1. It is recommended that the Gate Structure is upgraded to a more aesthetically pleasing one, so as to portray a more vibrant image of the School.
2. Paints/Wall finish to be used should be of high quality and have an anti-weathering component, such that the new gate structure can be used for up to 15 years without need for remedial works.
3. The Colors to be used on the gate should reflect the School Colors.

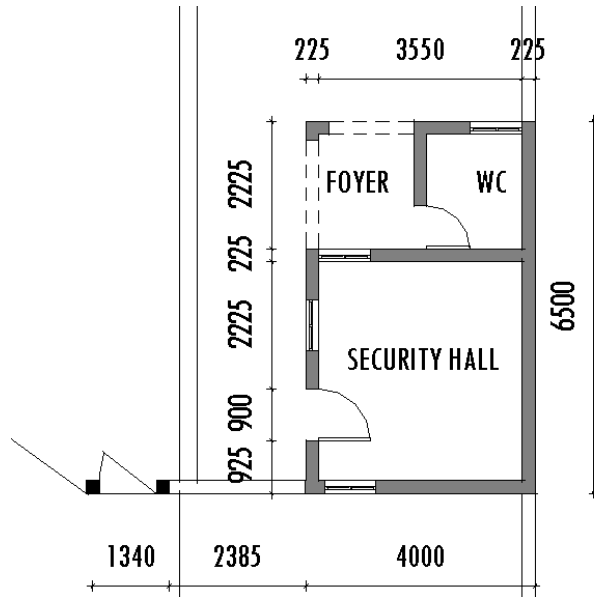
Fig 2. Gate House Floor Layout

1. The gate house is in fairly good condition, the roof structure was upgraded a while ago , and the external and aesthetic quality of the building is in need of remedy.
2. The windows are louver windows types and are in fairly good condition.
3. The internal walls are in good condition but have poor aesthetic quality.
4. The security hall space is constrained and cannot handle all the activities it would have been used for.
5. The door types are wooden panel doors and are not in good condition.

1. It is recommended that the Gate house is upgraded and all the items in fairly good condition be remedied.
2. It is of necessity (however optional) to increase the size of the security hall to accommodate a more defined space for:
Check in and Check-out Spaces for Students and Visitors.
3. The upgraded gate house should be done with the consideration of having the Pedestrian Access go through the gate house for better control and monitoring of pedestrian traffic.
